# **Important Notice**

#### Dear Customer Who Uses SPF/L-300, 312, 313, 330, 332 Sputtering System

# SPF/L-300, 312, 313, 330, 332 Series Sputtering System

**Inspection Manual**

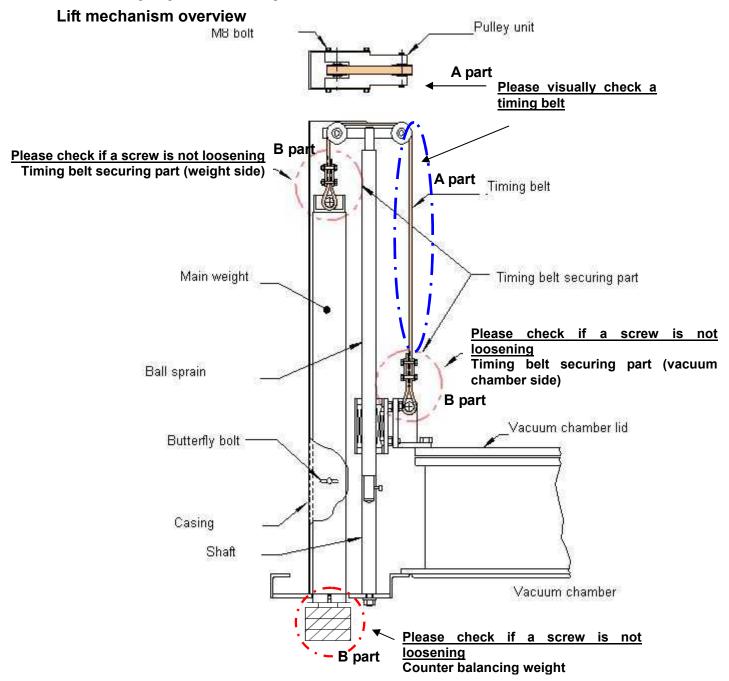
#### [Locations where a periodic inspection is necessary for safety]

A part: Check if there is any trouble on a timing belt.

B part: Check if the timing belt securing part (weight side and vacuum chamber side) and a screw of a counter balancing weight are not loosening.

Please replace it every three years basically.

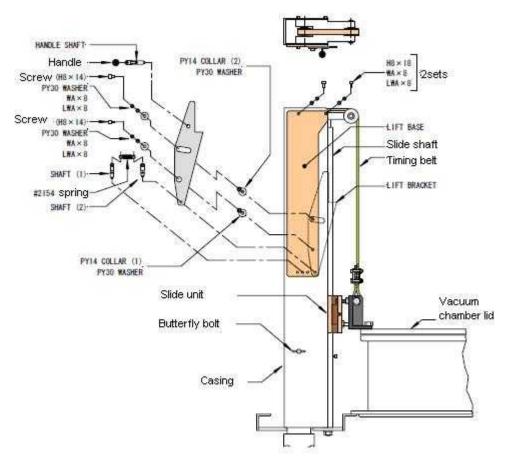
## **Locking Mechanism Reference Drawing Brief Version**

Since January 1994, a lift locking mechanism has been provided to a newly manufactured system to ensure safety. This function prevents a lid to fall off when the lid is opened (at upper limit position). Please consider installing a lift locking mechanism on this occasion as well.
